### **DAMAGE DUE TO STRANDING**

Vessel name:	Melody	
Registered port:	St John, USVI	
Assured:	Martin Andersson	
Hull identification number:	CAT47120B000	
Vessel description:	2000 model Catana 471 FRP sloop rigged catamaran with twin auxiliary diesel engines. Approximate dimensions 47'L x 25'B x 5'D (measurements not taken).	
Policy #:	CSRYP/172119	
Status:	Recommended to Underwriters as a Constructive Total Loss pending coverage.

This is to certify that the undersigned marine surveyor did attend the subject vessel on Saturday December 21<sup>st</sup>, 2019 where stranded on a breakwater in Boca Chica, Dominican Republic in order to determine the extent of damages due to stranding and make relevant recommendations to Underwriters.

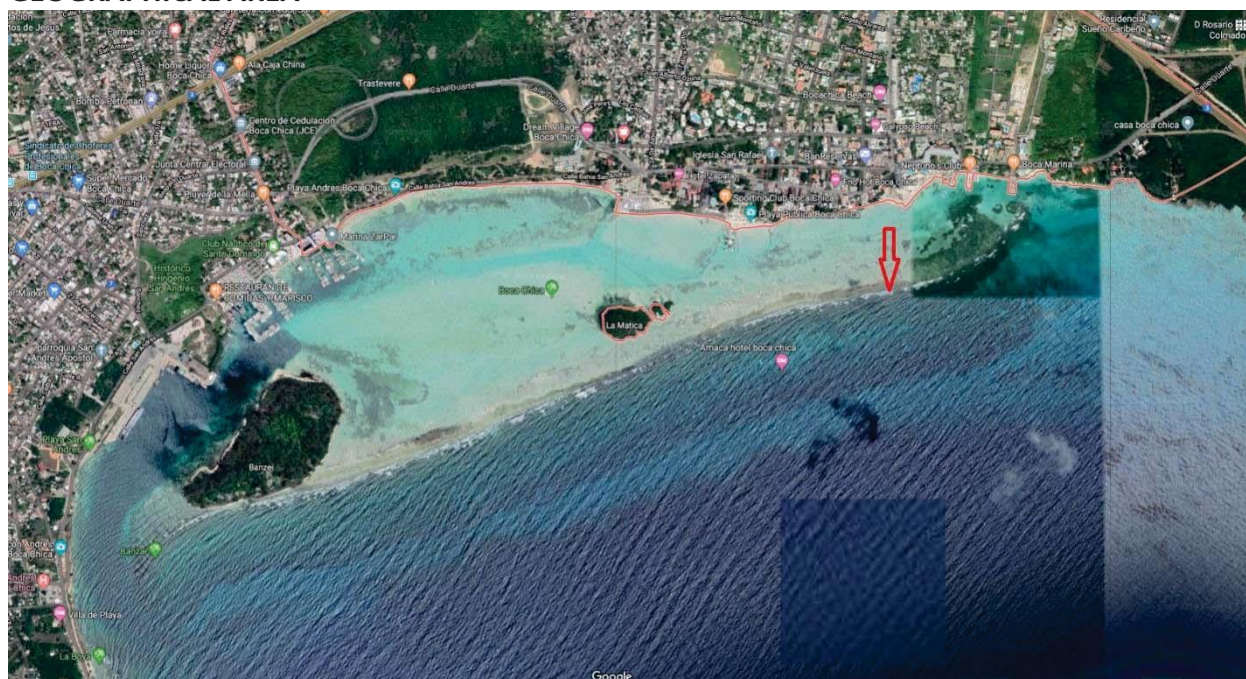
Satellite view of breakwater. Red arrow denoting approximate location of stranded vessel. The entrance to the harbor is on the far left.

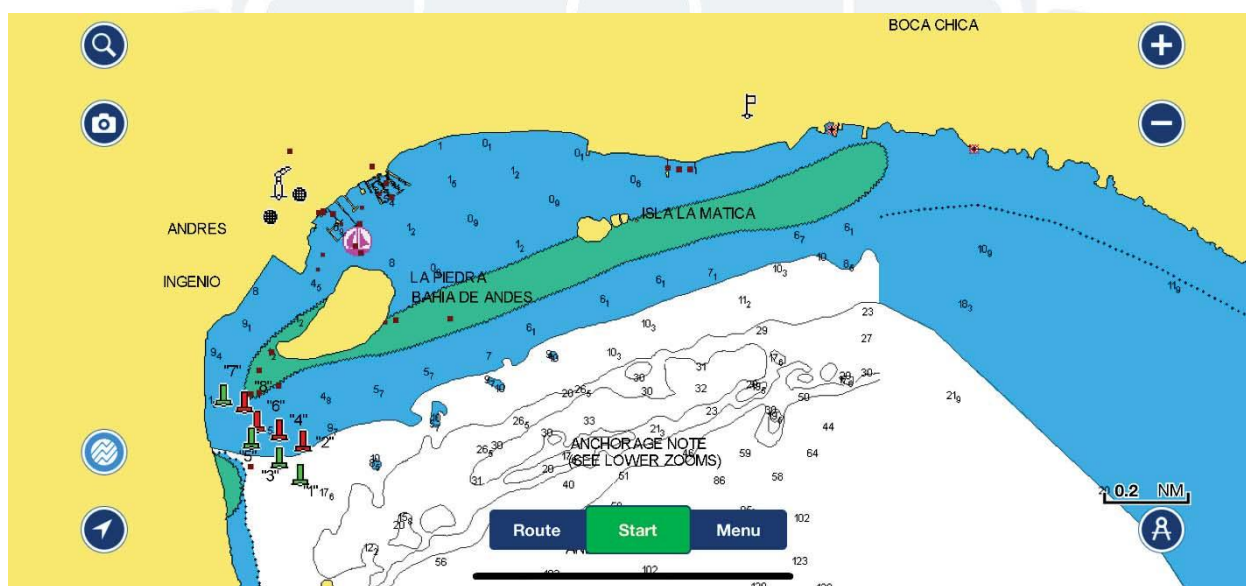
Breakwater shown on the latest Navionics chart data

The area of most concern with regards to potential seaworthiness is the procedure into a port in the dark with no local paper charts, no local cruising guide, no local knowledge, and what appear to be either defective, outdated, or absent electronic charts. The Master reports that the breakwater did not show up on the Raymarine Chartplotter. However, we have compared both current Raymarine charts and ones that are over two years old. The breakwater is clearly shown on both, as well as the entrance and marks to the harbour. We have asked that salvors take possession of the GPS unit and send it to us for further testing and determination of this fact.

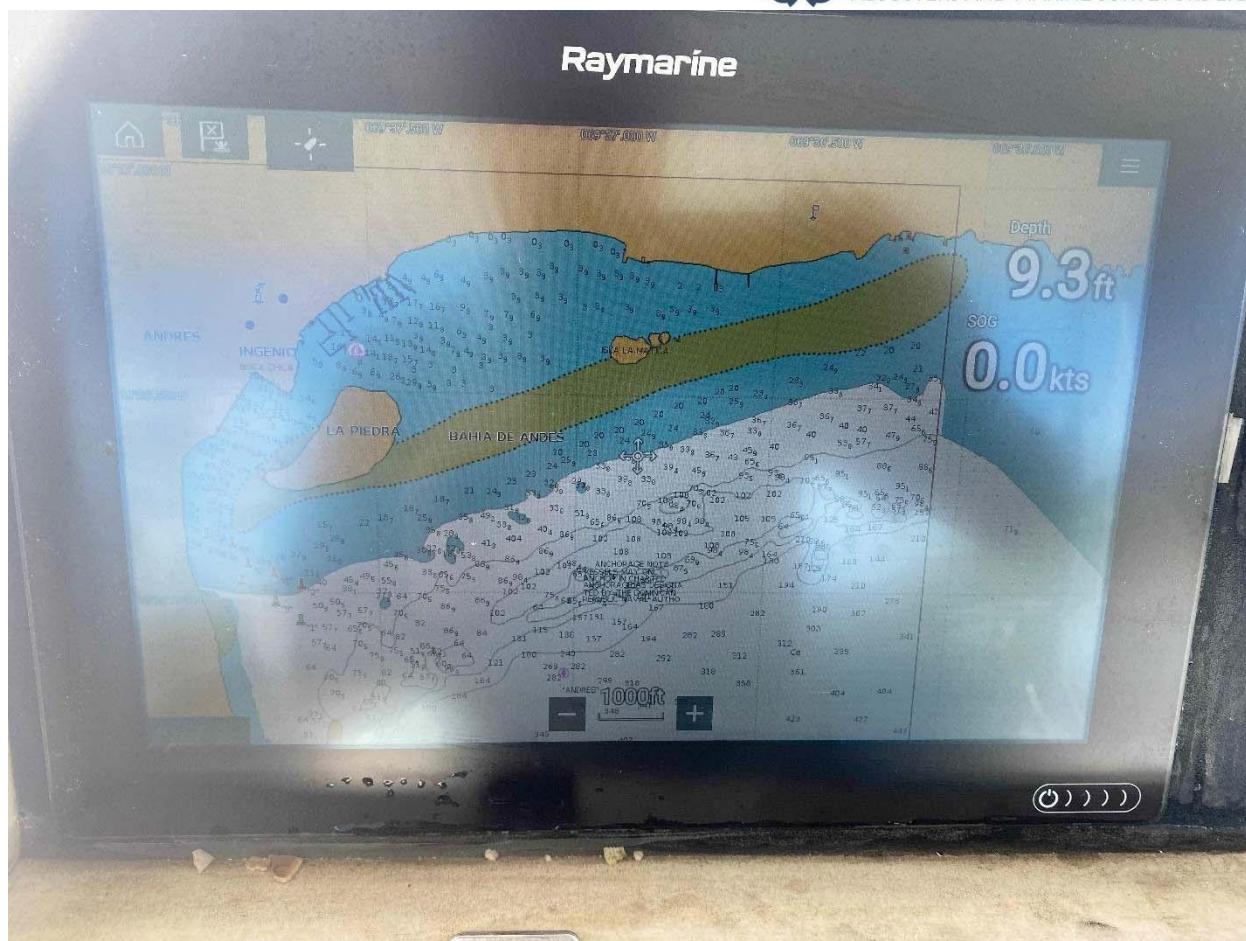
>2 year old chart data taken from our company vessel.

The breakwater is unlit at night.

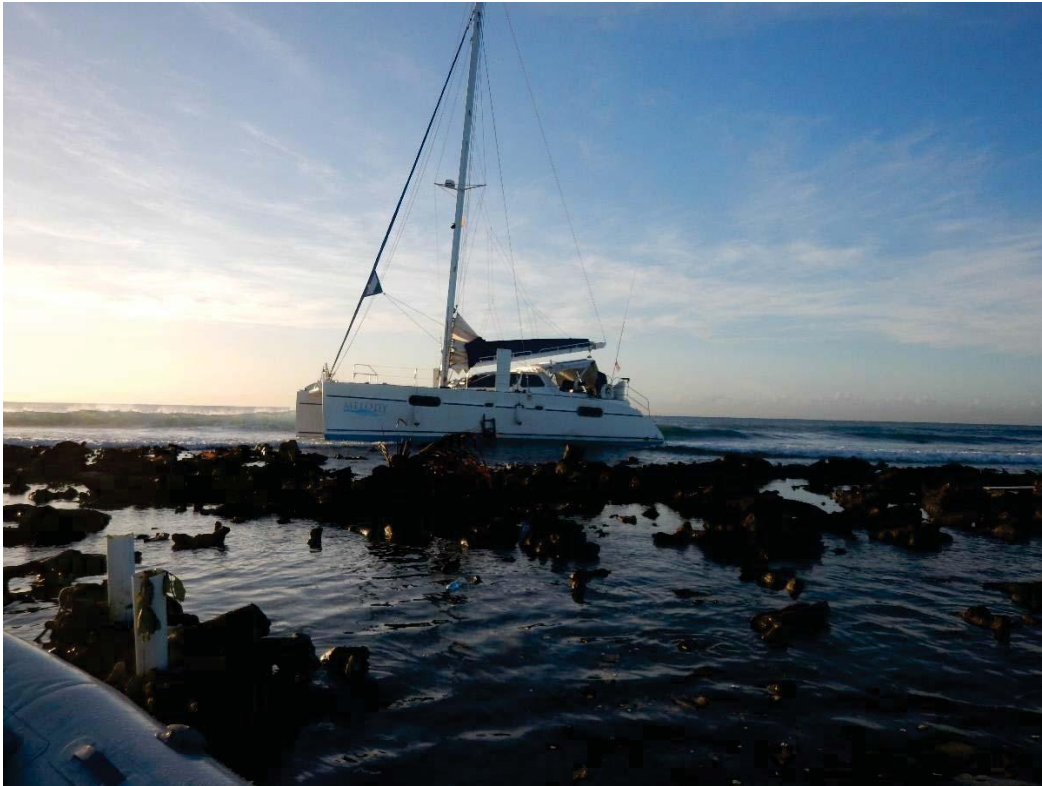
Vessel in current position

See our comments on estimated cost of repair below. We recommend that Underwriters consider this vessel as a Constructive Total Loss. In the event that coverage applies, we recommend that removal of wreck is considered over salvage.

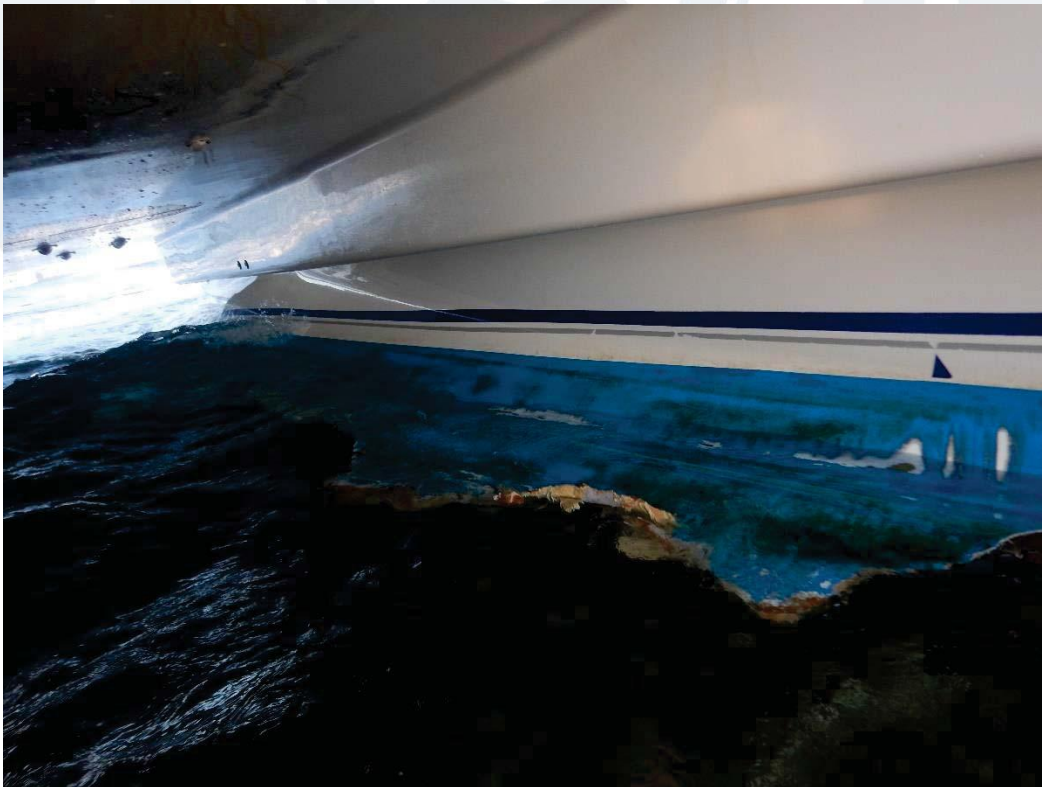
- The bottoms of both hulls are severely damaged. The breakwater is clearly visible from the inside of the vessel.
- The topsides are broken in large areas and badly deformed in others.

Broken hull bottom extending to topsides inboard port hull

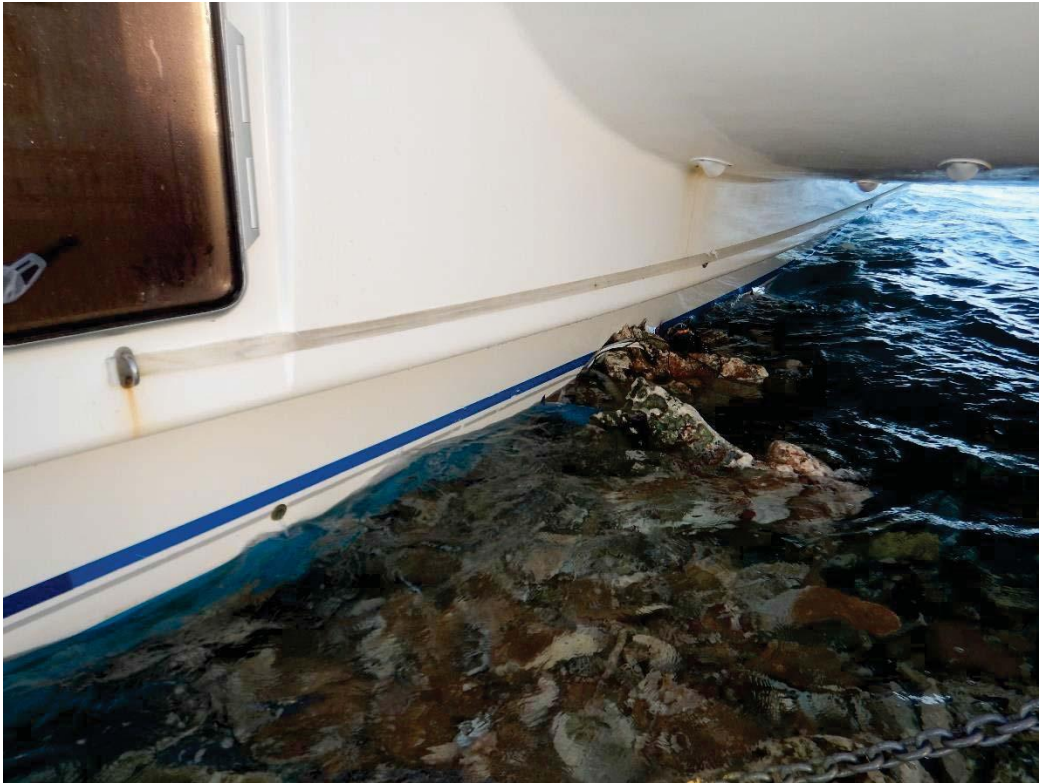
Impacted rock, starboard hull

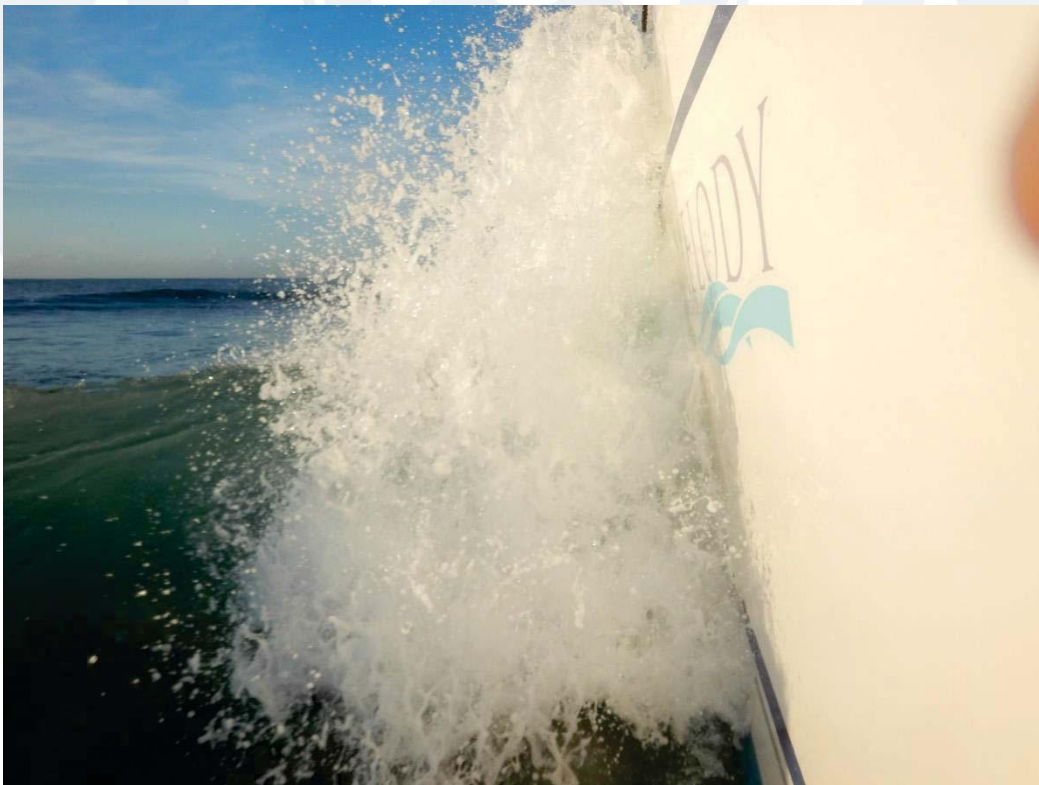
Wave action on seaward side

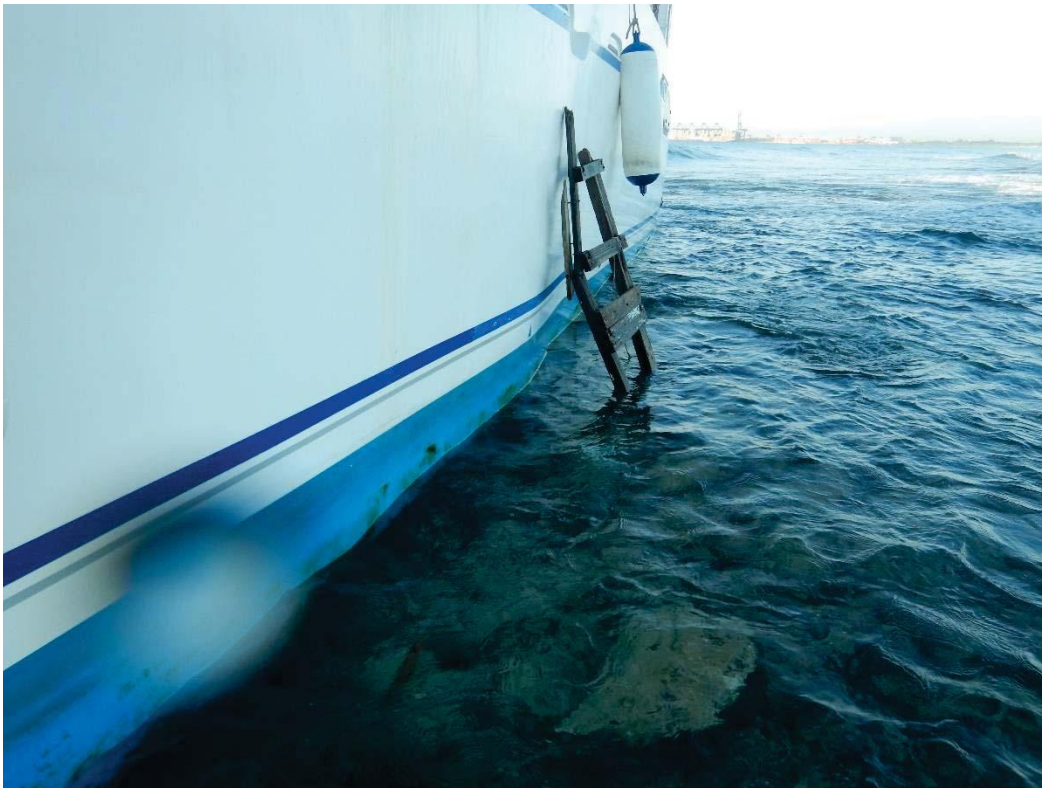
Deformed topsides outboard side, port hull.

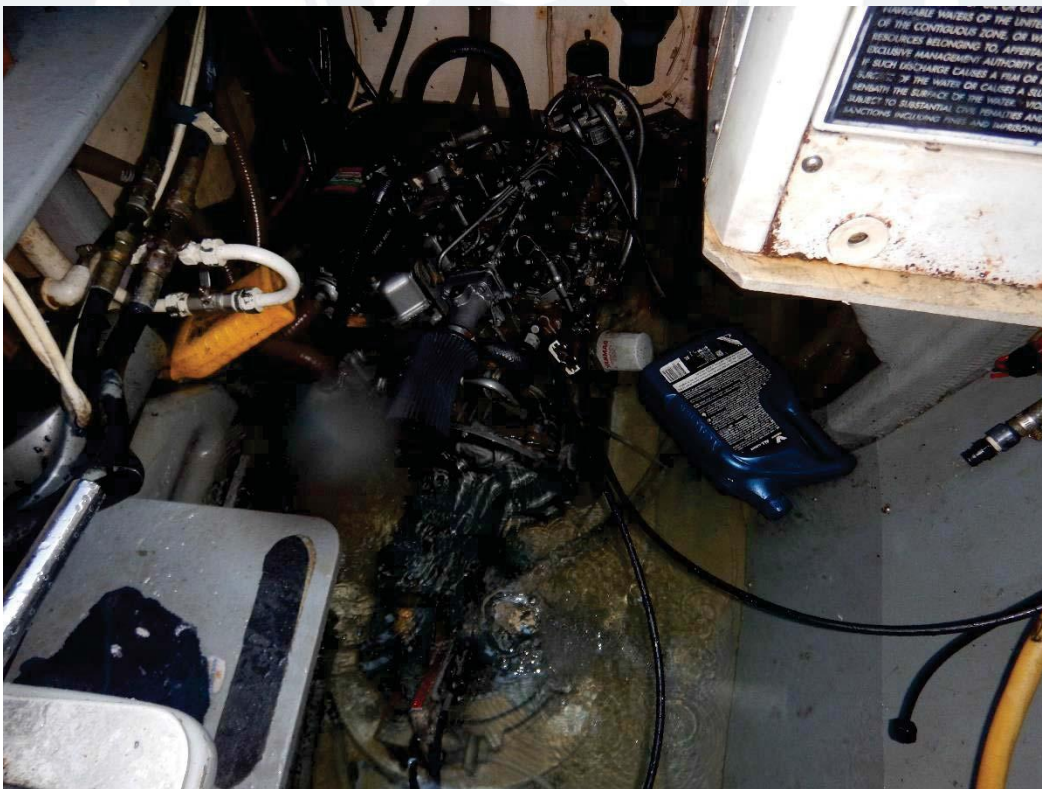
- Both engines have been broken from their mounts by forces from below. They lie on their sides partially submerged.
- It is our opinion that the damages to the engines are beyond those of economical repair.

Port engine

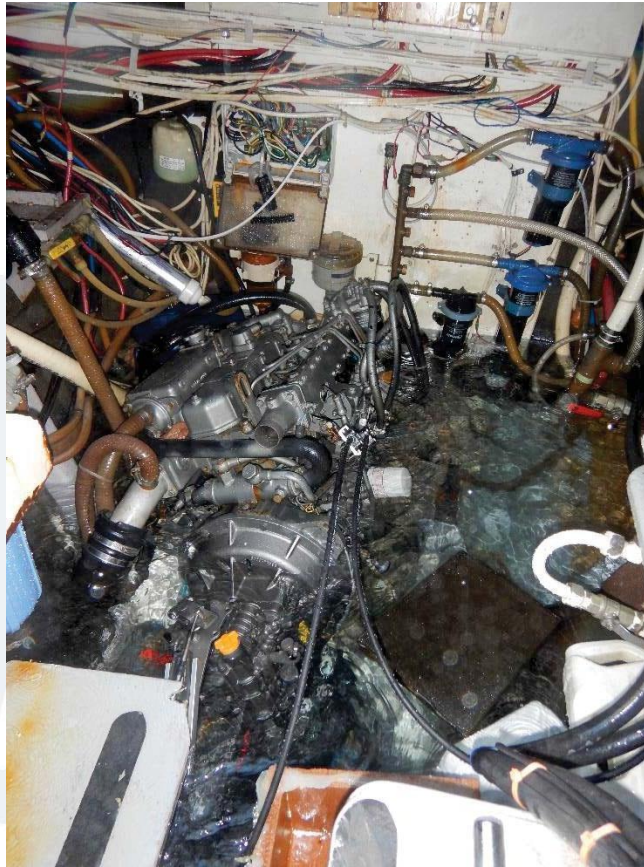
Starboard engine

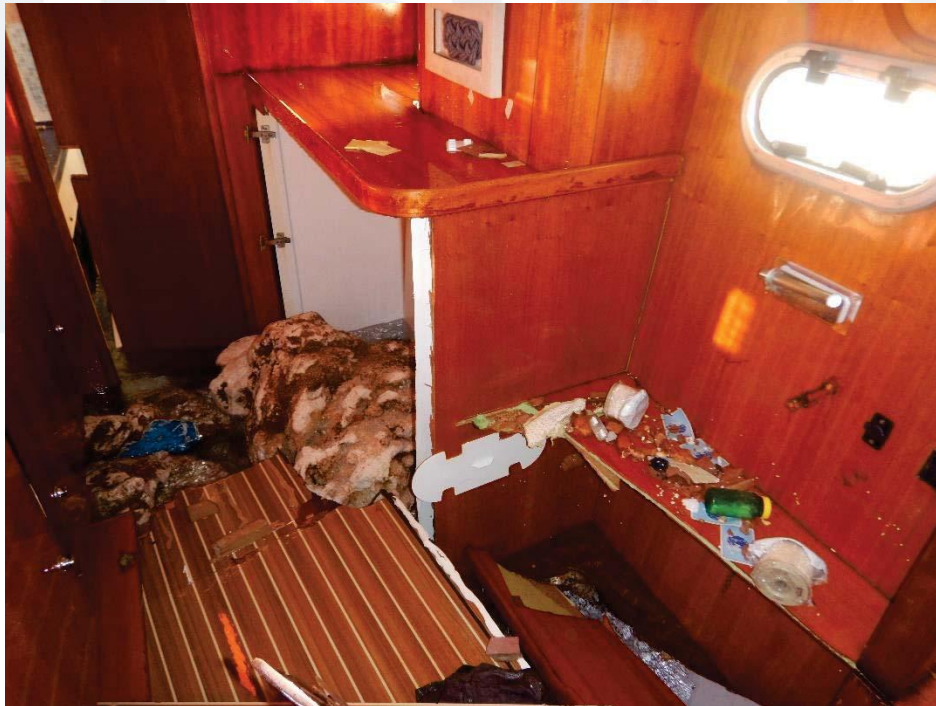
- The water level is approximately 1.5' above the cabin soles in both hulls. The continuous pounding from the swell has caused much of the cabinetry to break apart.
- All soft goods on the interiors of the hulls are also now wet.
- Only the area on the bridgedeck remains dry.

Starboard hull interior (breakwater)

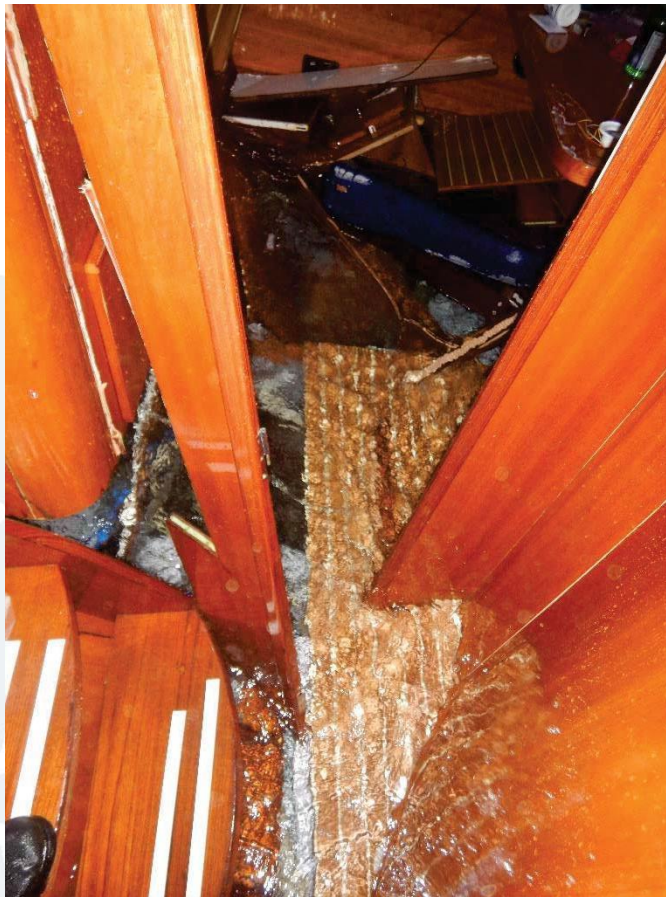
Port hull interior

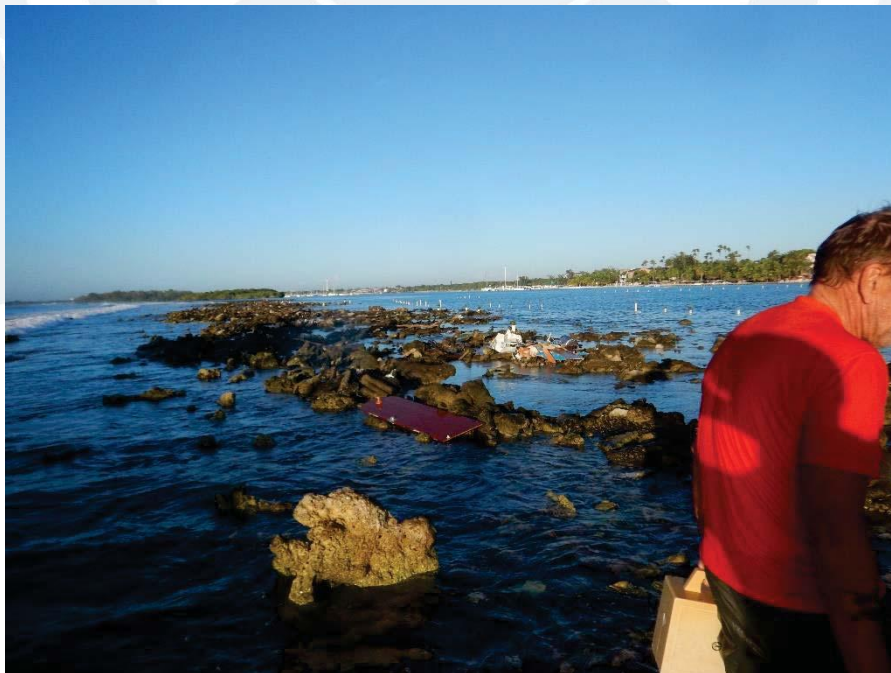
Debris on breakwater
